Submission to Planning Department

Response to Draft Outline Zoning Plan for Hoi Ha No S/NE-HH/C

August 2013

Printed and published by The Professional Commons

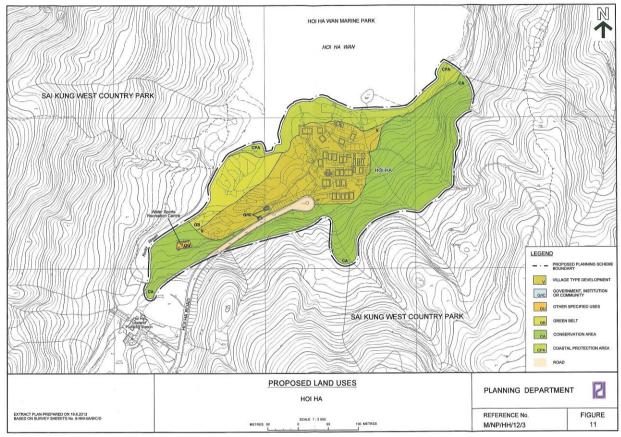
Figure 1.1 The draft Outline Zoning Plan map for Hoi Ha

Figure 1.1 shows the Draft Outline Zoning Plan for Hoi Ha as proposed by Planning Department in their report to Town Planning Board No S/NE-HH/C. We consider this to be a

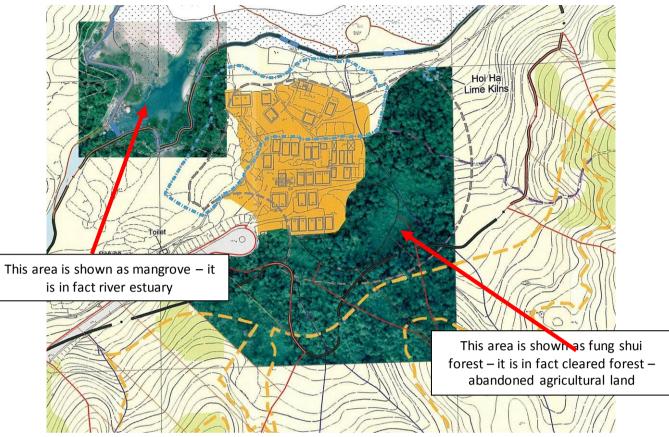
Figure 1.2 Overlay of aerial photos on to the Planning Department Land Usage map showing two major errors.

As some examples of the errors in the draft OZP we highlight here the land usage map, Figure 1.2 below. We have overlaid this with scaled aerial photos of the same area. It can be seen that what Planning Department describe as mangrove in the north-east corner of the village is in fact river, and that what they describe as Fung Shui Forest is at least 1/3 cleared land – abandoned farmland.

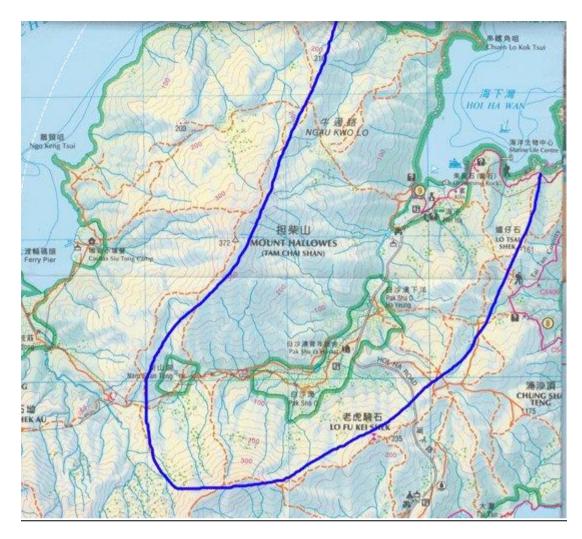
Figure 3.1 The Pak Sha O Valley

The extent of the Pak Sha O River Valley system is shown in Fig 3.1 below. It can be seen clearly that all the watershed rivers and stream feed directly into the Marine Park. Research (Bradbeer, Hodgson et al, 2008) has shown that fresh water springs in the Marine Park itself are fed by the water table supplied from wetlands in Pak Sha O. As will be shown in this report, recent re-instatement of abandoned agricultural land in Pak Sha O is already having an effect on the water quality entering the Marine Park.

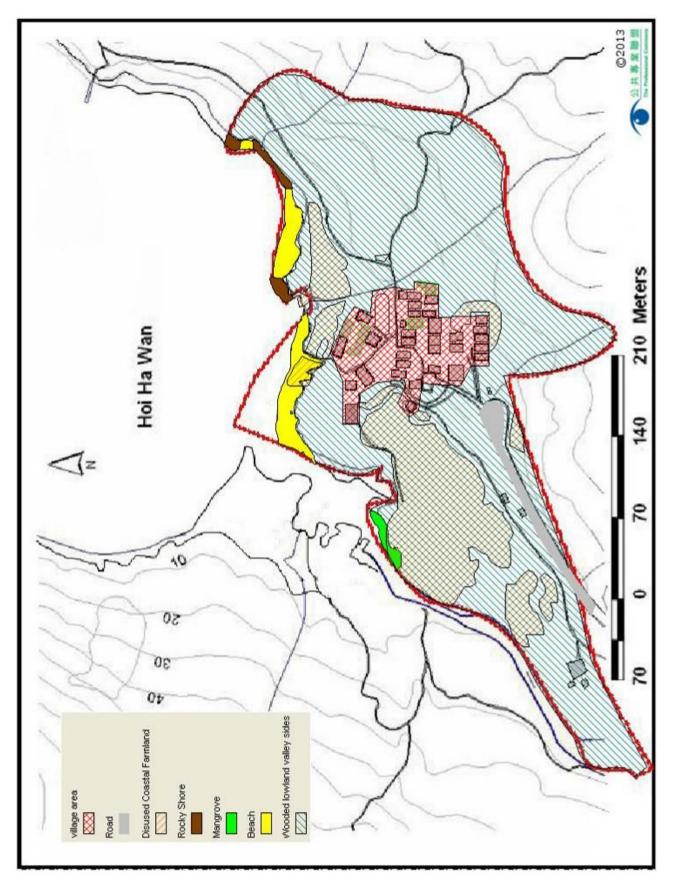
Figure 6.4. The Landscape Character Map of the Hoi Ha area based upon Standard Categories

Details of the key fixed existing land use are shown in Figure 6.4 below. This figure also shows the location of the special areas around the village like the Fung Shui Forest and the location of known endangered flora in the enclave.

Comparing the Figure 7.1 with Figure 6.4 shows that some of the developer owned lots are currently beach or under water. However, as shown below, sand accreted from the Pak Sha O River, means that much of the land, that is currently underwater, will be totally uncovered some time in the not too distant future. This will shift the high tide mark further out into the Marine Park area affording this "new" unprotected area no protection from any ecological harmful activities. It is clear that some protection must be given to this area to stop any future development from being carried out there.

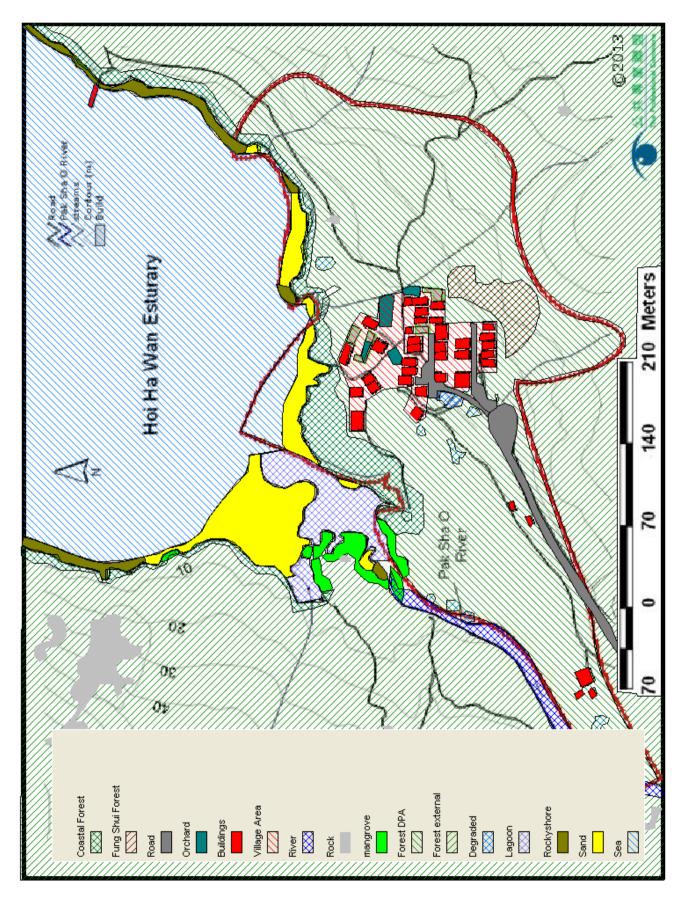
Figure 8.1. The land use in and around the area

During the forest surveys carried out for this report, it was noted that, as with the surrounding country park area, there is a need to carry out some reforestation work in within the OZP area. Areas identified for this need were areas of the coastal forest along the foreshore in front of the village, the Fung Shui Forest and several degraded areas shown in Figure 8.1. It is important that suitable species and tree density be maintained.

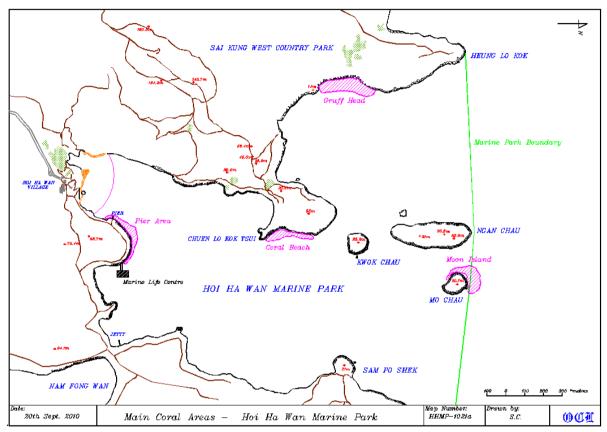
Figure 8.7. Map showing the location of the four main coral areas of Hoi Ha Wan

The Hoi Ha Wan Marine Park is a sheltered bay comprising 260Ha of sea surface area. It is formally known as Site of Special Scientific Interest (SSSI) No. 48 and Marine Park No. 2. Physically, it is located in the Northwest of the Sai Kung Country Park. The bay contains ecologically significant incipient coral areas scattered around its periphery (Cope and Morton 1988; Zou et al. 1992; Oceanway 2002, 2005, 2010, 2013) as well as several undersea areas populated with *Antipathes* spp. There are also several small non-zoned mangrove areas (Chan 1992; Tam 2012) and a small lagoon kept in place by a dynamic beach and a series of sand bars and spits (Morton et al. 1992) directly in front of a small village. Figure 8.7 show the location of the four main coral areas of Hoi Ha Wan. These are Pier Area, Coral Beach, Moon Island and Gruff Head.

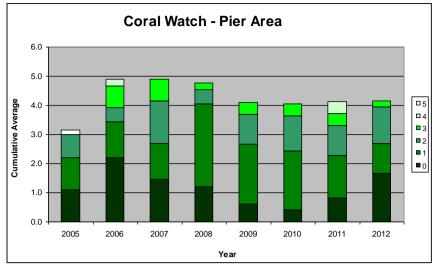
Figure 8.9. The Cumulative Average Value for the Pier Area near Hoi Ha Wan Marine Park.

Of the four coral areas within the Marine park, the Pier Coral Area, by virtue of its proximity, is the most likely to be impacted by the Hoi Ha Village. The Coral Watch data for the Pier Area is presented in Figure 8.9. Since 2009, the coral health at the Pier Area has been less than the average for all areas. Furthermore the ratio of unbleached coral at the Pier Area has been less than the average since 2007. The low value in 2005 was due to an abnormal hypoxic event that impacted the whole of Mirs Bay.

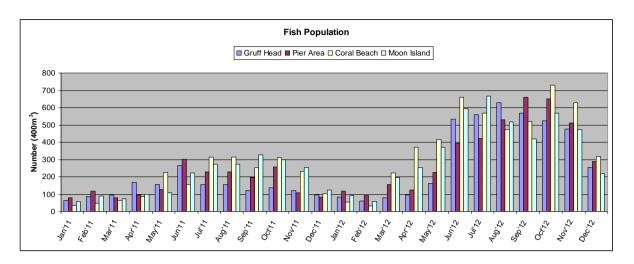
Figure 8.11. The fish population in the four coral areas of Hoi Ha Wan.

The reef fish populations within the Marine Park have been increasing over the past two years. This trend was the result of two separate surveys; WWF (Cornish 2009) and Oceanway (Oceanway 2013) The Oceanway data is in Figure 8.11. The number of reef fish recorded has almost doubled year on year.

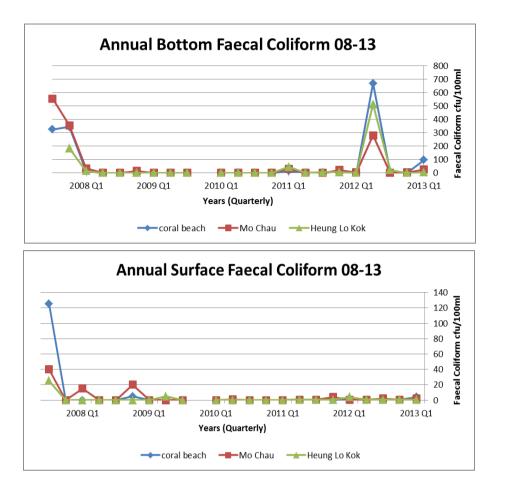
Figure 8.12 Typical faecal coliform parameters of Hoi Ha Wan.

For Hoi Ha Wan, the Water Quality Objectives set the levels of *E. coli* at a maximum level of 180 per 100mL calculated as the mean for all samples collected from March to October inclusive. This is set by the Water Pollution Control Ordinance (WPCO). From the measured results, the amount was below set limits for most of the time. The peak in the second quarter of 2012 is not explained.

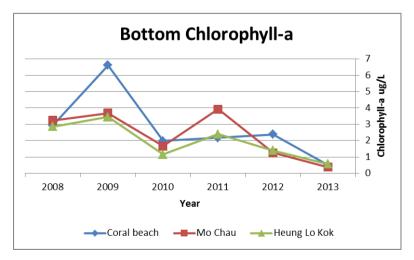
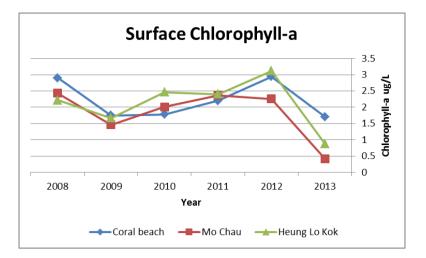
Figure 8.13 Typical chloropyll-a parameters of Hoi Ha Wan.

The amount of chloropyll-a in the water column is an indirect indicator of the plant nutrients in the water. An excess of chlorophyll-a indicates an algal bloom that may reduce water clarity and deplete dissolved oxygen levels. The locations of the measurements taken are the same as those measured for Faecal Coliform. The results are in Figure 8.13.

For the values obtained from Hoi Ha we can see that the innermost station at coral beach is shown to be higher than the values measured in other areas; further away from Hoi Ha. It is likely that this indicates a possible pollution source from the village. Typically this pollution originates from agriculture activity and the recent farming activities at Pak Sha O are implicated as a possible source. However the overall decrease in overall values is suggestive of an overall reduction of the total chlorophyl-a pollution.

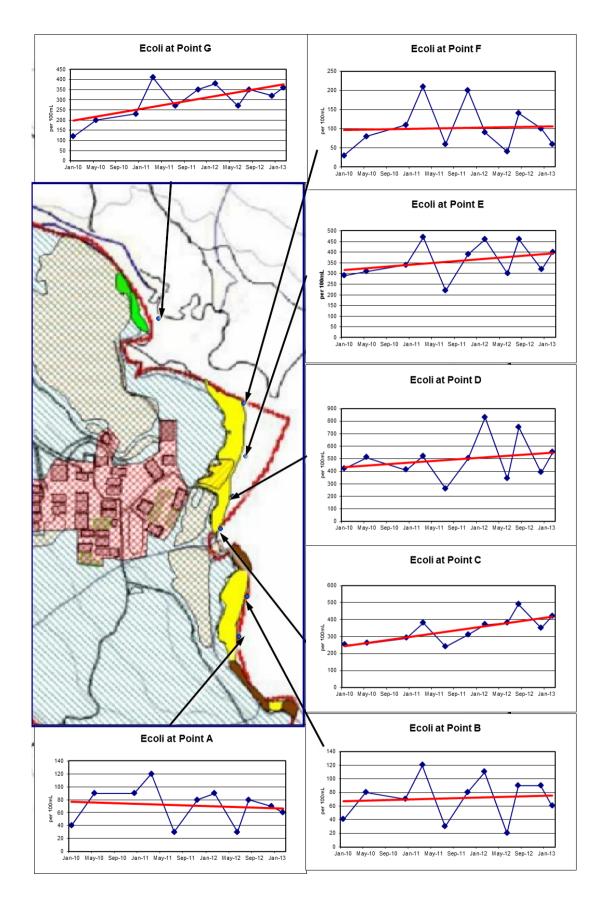
Figure 8.14. The levels of *E. coli* measured at low tide from ground water seepage at the beach

Regarding the *E. coli* data for the beach at Hoi Ha, points C, D and E have the most likely source from the village. The dips are probably due to drops in leakage after septic tank clearing, ground water flushing, or times when residents leave the area for holidays overseas.

International standards put the safe beach levels of *E. coli* at 400 per 100mL of water. Hong Kong Water Quality Standards allocates a maximum average of 180 per 100mL, for multiple testing. The measurements taken at Hoi Ha are single measurements, so it is best to apply international standards for analysis. This is currently exceeded at points C, D & E. The source of the *E. coli* at G is from the river valley and maybe up as far as Pak Sha O, and is just under the 400 limit. An inspection of Pak Sha O revealed several septic tanks within 10m of the river. The building near the existing BBQ area, and the BBQ areas themselves may also be a source of this pollution. But neither has been checked for confirmation of this.

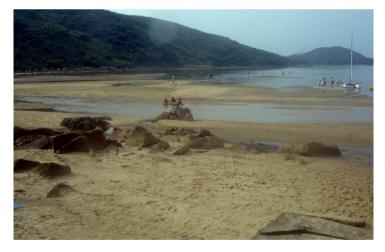
Figure 8.15 The beach at Hoi Ha at low tide. (PH 2013)

There has been a lot of scientific controversy regarding the stabilization role the mangroves and Coastal Forest play in this and some other areas as well. It is known that mangrove and coastal forests reduce water flow energy behind them during periods of high wave action. However such periods are very short at Hoi Ha and the wave action is not that significant. Waves of 9m were recorded at Nine Pins during the passage of Vicente (Chiu-Leung 2013). The corresponding height at Hoi ha was only 2.1m for just over 2 hours. Typhoon Vicente was a statistically once in ten year occurrence. It is therefore doubtful that beach is being shaped by the flora present. The lack of back mangroves (Chan 1992, Tam 2013) also indicate that the normal stabilization via successive flora processes is not occurring along the beach at Hoi Ha. This means that there are other factors controlling the beach structure. Experts suggest that the river plays a far more important role in providing a constant source of sand for beach accretion and the river flow changing the shape of the beach (Morton and Ong Che 1992). This means that the flow rate of the river is a critical factor in determining the shape of the beach. It can be observed from past aerial photographs that the beach underwent two significant shape changes in recent time. One was the building of the road in and the dredging of the bay the 1980s (Chan 1992). It has been accepted that the change caused by the road was due to the increase in water flow caused by the change in surface hydrology brought about by the drainage of the road (Morton 1992). This corresponded to an increase in the rate of water flowing from the river during periods of heavy rain.

The result of this is that the hydrology of the river valley is crucial in maintaining the beach. Any changes in the river valley will change the flow rate of the river. If the change is significant, then the lagoon will wash out, the beach will decrease in size, the mangrove community will thin and the ecology of the area will change. It is also highly likely that the current coastal forest area will decrease in size.

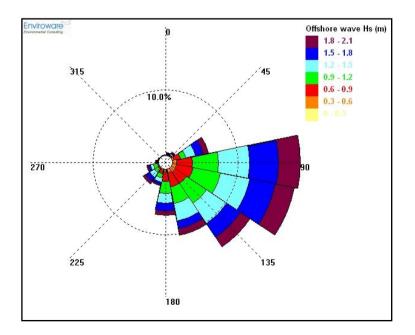
Figure 8.17 The Significant Wave Height Data for Mirs Bay during 2012.

Hoi Ha Wan is a protected bay (Morton 1983). Wave data for Mirs Bay was collected during the entire of 2012 by Teledyne ADCP's. This data is shown in Figure 8.17. The northward facing entrance to the bay and the barrier islands excludes much of the wave action present in Mirs Bay, but certain directions will pass the barrier islands. From this data the majority of the wave direction in Mirs Bay is from the west, south-west direction (Yamamoto 2012). Internal reflections from the rocky shore would restrict the wave directional spread to 90 degrees centred on the north direction. Wave data recorded for Mir's Bay in 2012 shows that less than 1% of the time the recorded significant wave height in the 0.3m band originating at an angle that could enter the bay and strike the beach (Figure 8.18). From this data the majority of the wave action in Mirs Bay is mainly from the south-east direction. Hoi Ha Wan is naturally protected from these waves first by Tap Mun (Grass Island) and the Wan Chai Peninsula.

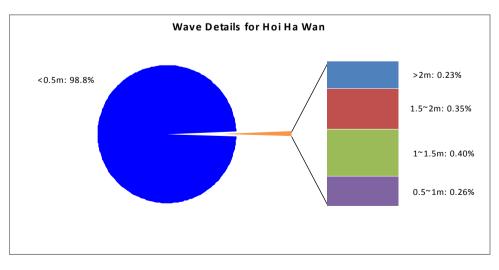
Figure 8.19 General wave data for Hoi Ha Wan (2012)

The wave data for Hoi Ha is shown graphically in Figure 8.19. This clearly shows that for 98.8% of 2012, the wave size in Hoi Ha Wan was less than 0.5m. The bar chart breakdown of the remaining 1.2% of the time details the period of time that the beach is subject to a wave action that can cause impact. Such data is fairly typical of sheltered, protected bays in Hong Kong.

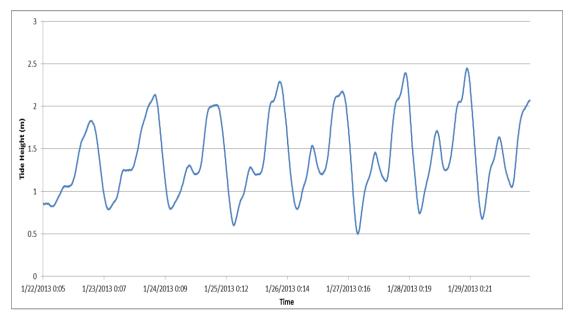
Figure 8.20. Typical tide data for Hoi Ha Wan (22nd ~ 29th January 2013).

The WWF Hoi Ha Wan Marine Life Centre has a Teledyne OPM tide gauge fitted with all data streamed to the internet as part of the DataBuoy Project. Data is collected every 5 minutes. Typical tide data collected is shown in Figure 8.20. There is a slight time lag in terms of maximum times and heights when compared to more exposed areas of Hong Kong. This is to be expected. Yearly tide gauge summary data for 2012 is shown in Table 8.21 below.

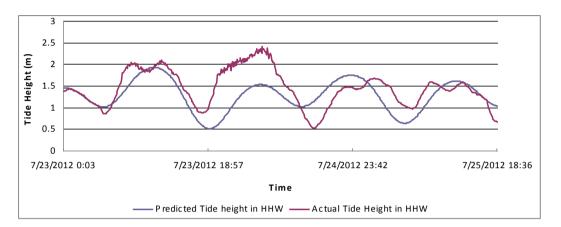
Table 8.22 Typhoon Vicente Storm Surge Data for Hoi Ha Wan - 2012.

The storm surge data for Hoi Ha suggests that the area receives less impact than many other areas of Hong Kong. This is probably due to the sheltered nature of the bay. The storm surge condition can be exacerbated by high waves. Again the sheltered position of Hoi Ha suggests that the impacts would be far less than other areas like Big Wave Bay for example.

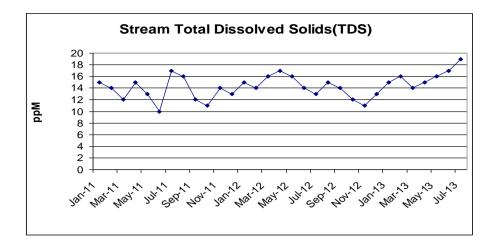
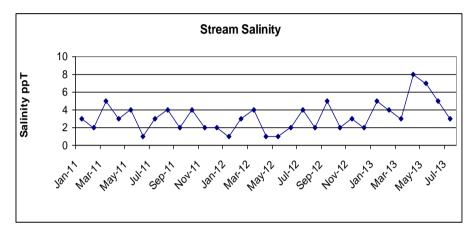
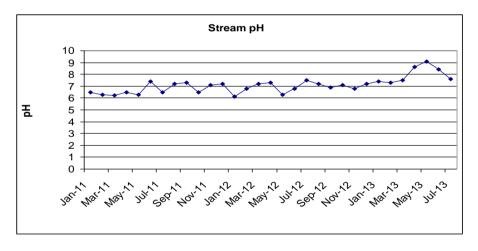
Figure 8.24 Typical water parameters of the Pak Sha O River

The Pak Sha O River has a significant impact on the Hoi Ha Wan Marine Park. It is a source of fresh water, sand and pollution. It also is the major architect of the beach on the western side of the village. The hydrology of this system is a balance of forces between the stability of the beach and the energy of the water during and after periods of heavy rains. Typical river water parameters are shown in Figure 8.24.

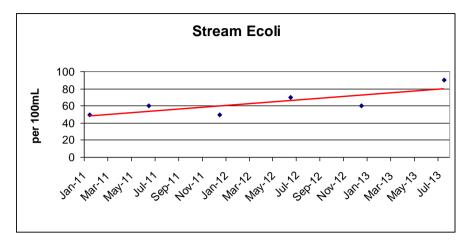
Figure 8.25. The Ecoli results for the Pak Sha O River at the Hoi Ha Estuary

Other parameters measured included *E. coli* measured twice every year. Five measurements were recorded and the average determined from the results. This was deemed as being the minimum data needed to pick up a gradual change

The trend line shows an increase from January 2011 of just over 35%.

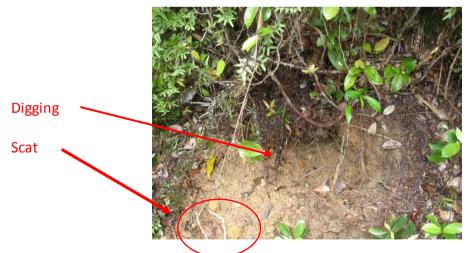
Figure 8.28. Photographs of a foraging area and associated scat taken in the DPA near the stream.

The sightings were concentrated around water sources. Previously, before the back row of houses were constructed, animals were frequently seen around areas near the Fung Shui Forest. The water sources in this area are either filled in to stop mosquito breeding or changes in the hydrology in this area have removed the water. This in turn has led to a shift in the location of animals to the valley of the Pak Sha O river. It is now common to see foraging marks and scat of mammals in the valley area.

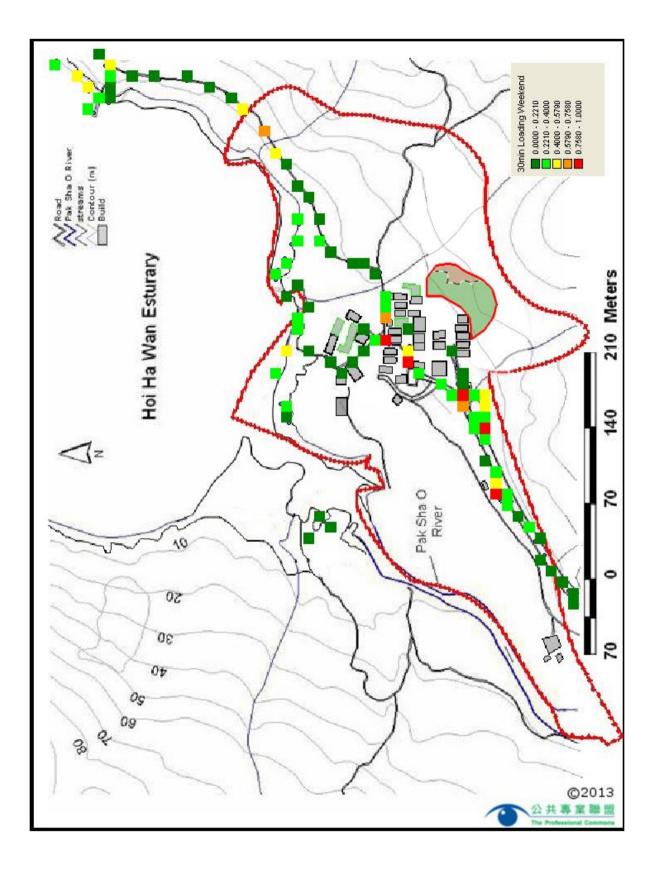
Figure 9.3. 60 Minute Infrastructure and Facility Loading, Fine Holiday, for Hoi Ha Village.

In terms of the old carrying capacity figures and notion, the visitors to the area, during the peak times (weekends/holidays with good weather) could increase by about 20% at peak times before maximum limits would be reached. During weekdays, this figure increases to 40% more loading. This report does not suggest that this area be further exploited; however, it is worthwhile to show that the area is currently being underutilized. Needless to say an EIA on the current visitation and its impact on the area would be necessary to determining more detailed information.
